COSTA DE COCOS WIND-DIESEL HYBRID SYSTEM

RESULTS OF THREE YEARS OF MONITORING

Abraham Ellis, Luis Estrada

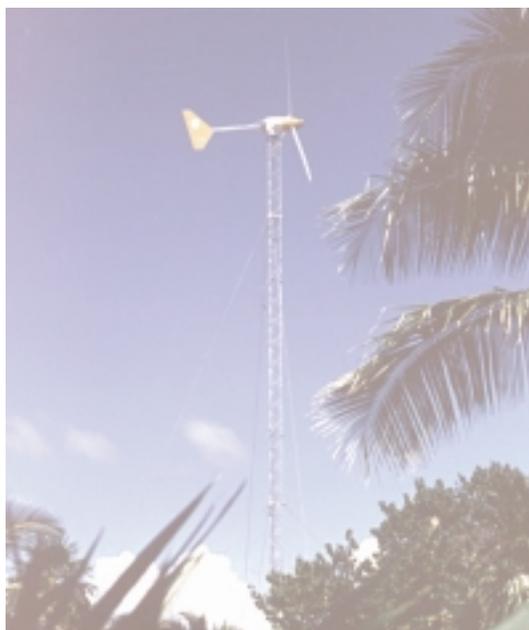
Fig 1: Bergey Exel wind turbine at Costa de Cocos, Quintana Roo, Mexico.

The wind turbine has been performing satisfactorily. The corrosion package has kept the turbine and tower in good overall condition. However, there is evidence of corrosion attacking the generator can itself and the hub plate. The guy wires exhibit moderate corrosion, especially at the top end. Corrosion is also beginning to affect the furling cable and winch. Turbine noise has been a nuisance for the owner and some patrons. The noise level is not high, but it is relentless. Since late in 1999, the turbine has been producing a low-frequency noise around cut-in wind speed. The source of the noise has not been identified.

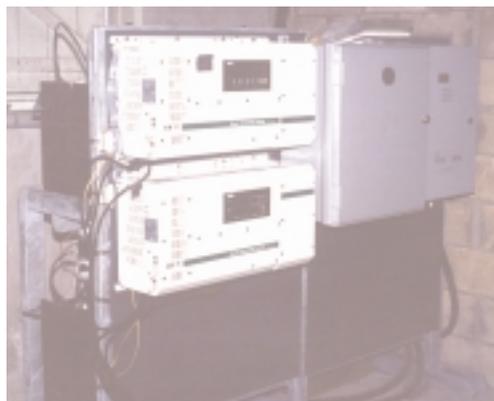
Fig 2: View of the system module with electronics in the front side and batteries on the back side.

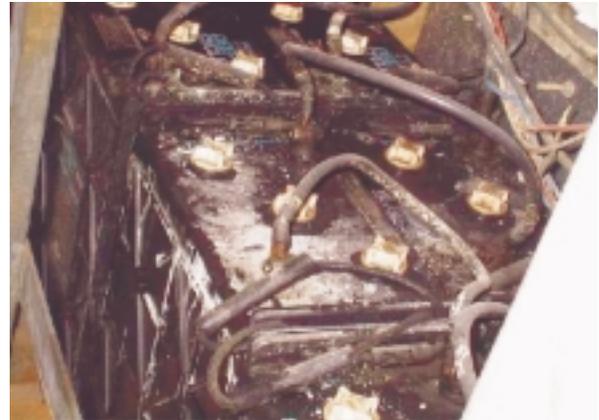
in excess of 50 °C (hourly average) were recorded while charging from the generator. It was also observed that the top-rack batteries operated at higher temperature than the lower-rack batteries, which was initially attributed to the proximity to the cool concrete floor. In April 2000, an entire string (top rack) was disconnected from the bank because 6 of its 8 batteries were bad. This string was physically located immediately behind the inverters. It is very likely that inverter heating contributed to the high operating temperature of this string. The rack design also makes it difficult to maintain the lower rack batteries. These batteries are exposed to acid spilled from the top rack and are difficult to water (Fig. 4).

Fig. 4. Lower-rack batteries splattered with acid from the top rack batteries (April, 2000)

It is important to include thermal considerations in the design of battery racks or containers. Even small thermal differences among batteries can contribute to battery decay in the long run. Ideally, the entire battery bank should be placed in a location insulated from sources or sinks of heat such as inverters or bare concrete floors. They should be placed in a plastic container to reduce the risk of acid spills. Any bad batteries should be replaced as soon as possible. This minimizes the chances of other batteries decaying rapidly. A strict maintenance schedule and procedure should be established to take care of batteries. This includes not only adding distilled water, but also monitoring battery temperature and voltage, and keeping them clean. Safety equipment such as goggles and rubber gloves must be used.

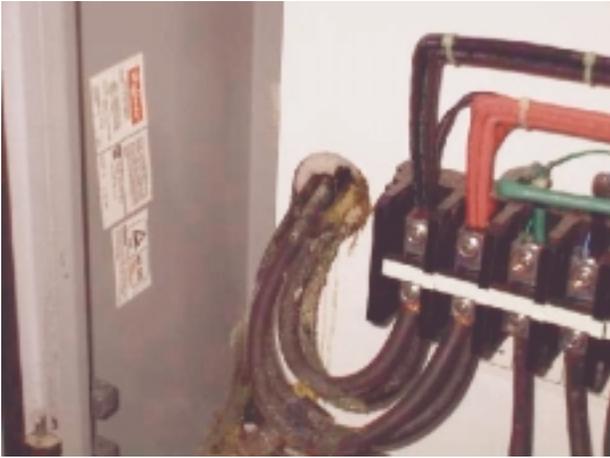
The balance-of-system components (switches, fuses, conductors, etc) located in the battery room are in good overall condition. Corrosion has begun to enter the fuse enclosure via battery cables (Fig 5). This will become a problem if not controlled.

Fig. 5. Corrosion entering the dc enclosure at Costa de Cocos (April, 2000)

All possible precautions should be taken to control corrosion in humid, coastal environments. This includes the use of stainless-steel hardware, corrosion-resistant enclosures and accessories. Any parts untreated against corrosion will corrode very quickly. Anti-corrosion grease should be applied to all field-installed electrical connections. Corrosion is particularly hard to control in the presence of salt spray or battery acid. Special care should be afforded to grease guy wires and furling mechanism periodically because corrosion can quickly render them unsafe or inoperable. Batteries should be cleaned periodically and all acid spills should be neutralized and cleaned as soon as they occur. The operator should follow a strict preventive maintenance schedule.
